# **Confidential Partial Water Intrusion & Limited Microbial Assessment with Remediation Protocols**

**for the:**  
**MiraLago Estates Clubhouse**

ERR PROJECT NO. 20-0349-01

**Partial Inspection Date: December 29<sup>th</sup>, 2020**

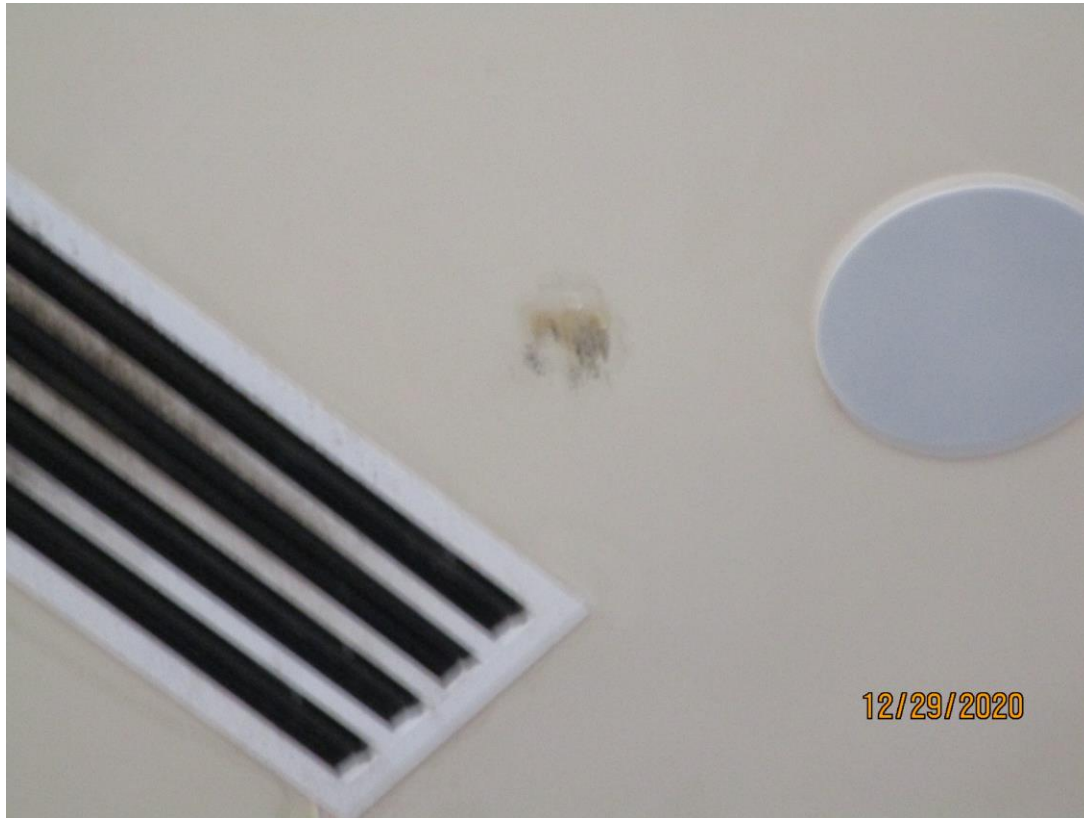
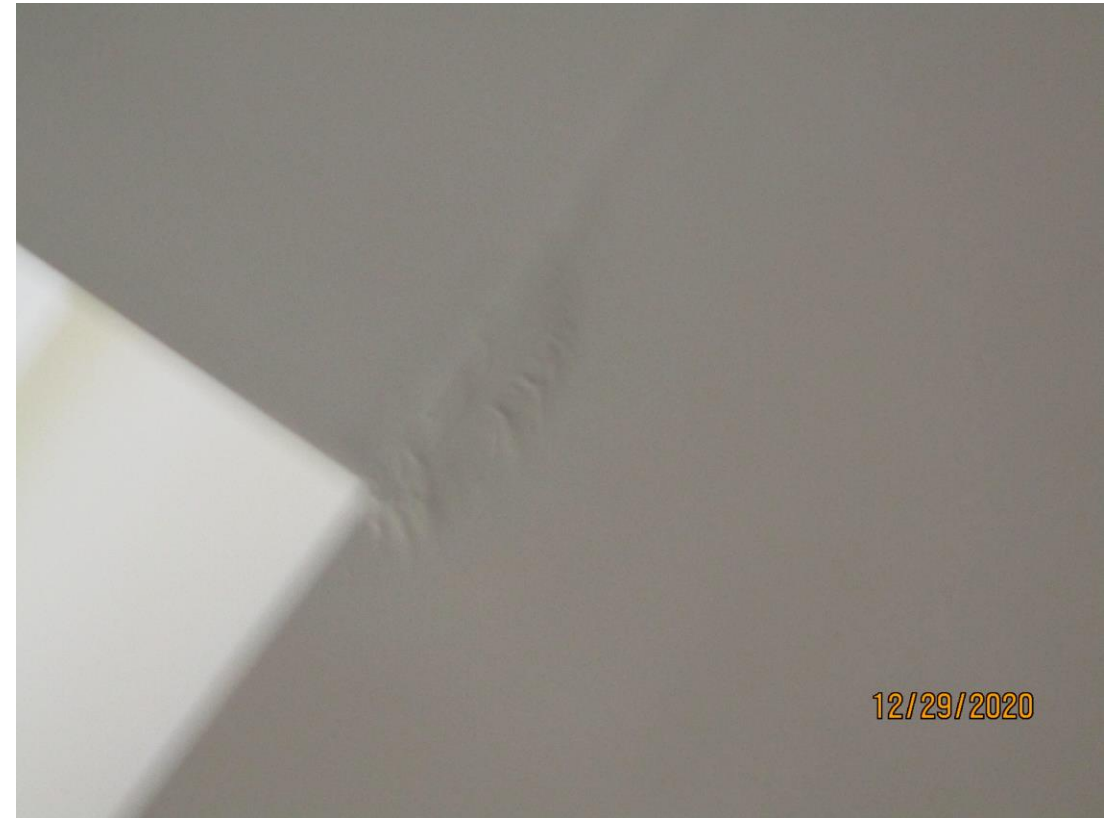
- There are visible water stains on the ceiling and around the A/C vents, which appear to be from the roof and from excessive condensation.
- There is heavy mold growth in the A/C vents, ducts and ceiling.
- There is visible water damage on the **East** wall below the windows.
- The **South** wall below the windows appears to have visible water damage from the windows or from under the base of the **South** wall.
- The relative temperature was **63 F°** and the relative humidity was found up to **66%**. The elevated humidity is contributing to the mold growth.
- There is visible surface mold inside the **Cathedral ceiling**.
- **One (1)** tape sample collected from the **Ballroom East Wall behind the baseboard** identified **Penicillium/ Aspergillus** too numerous to count ("TNTC"), scientific findings attached herein.

# Water stain and mold growth on **Majestic Ballroom** ceiling

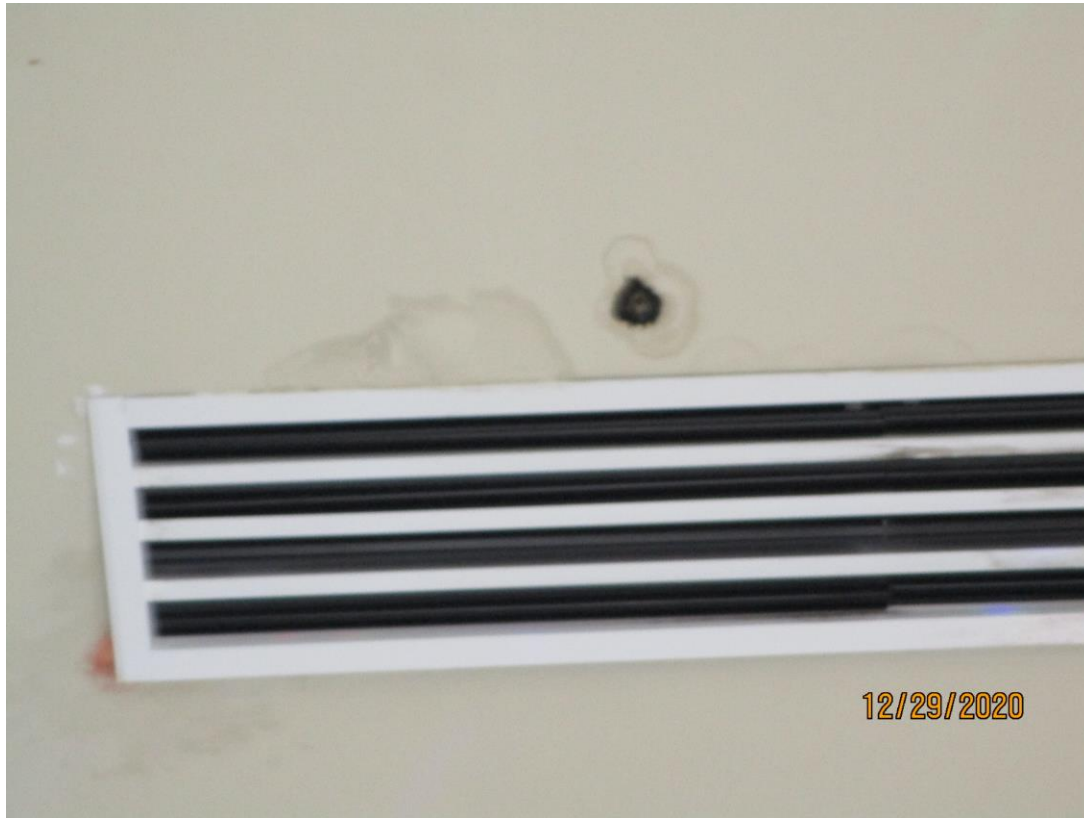
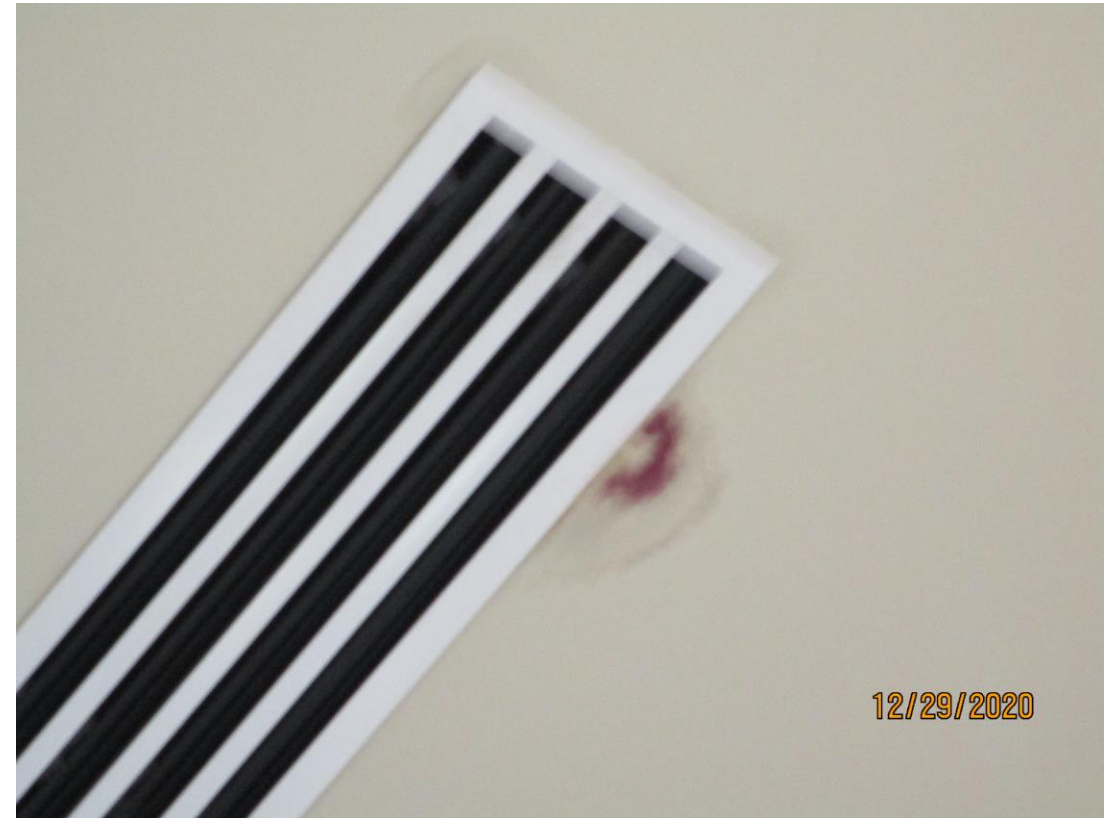
# Water stain and mold growth on **Majestic Ballroom** ceiling

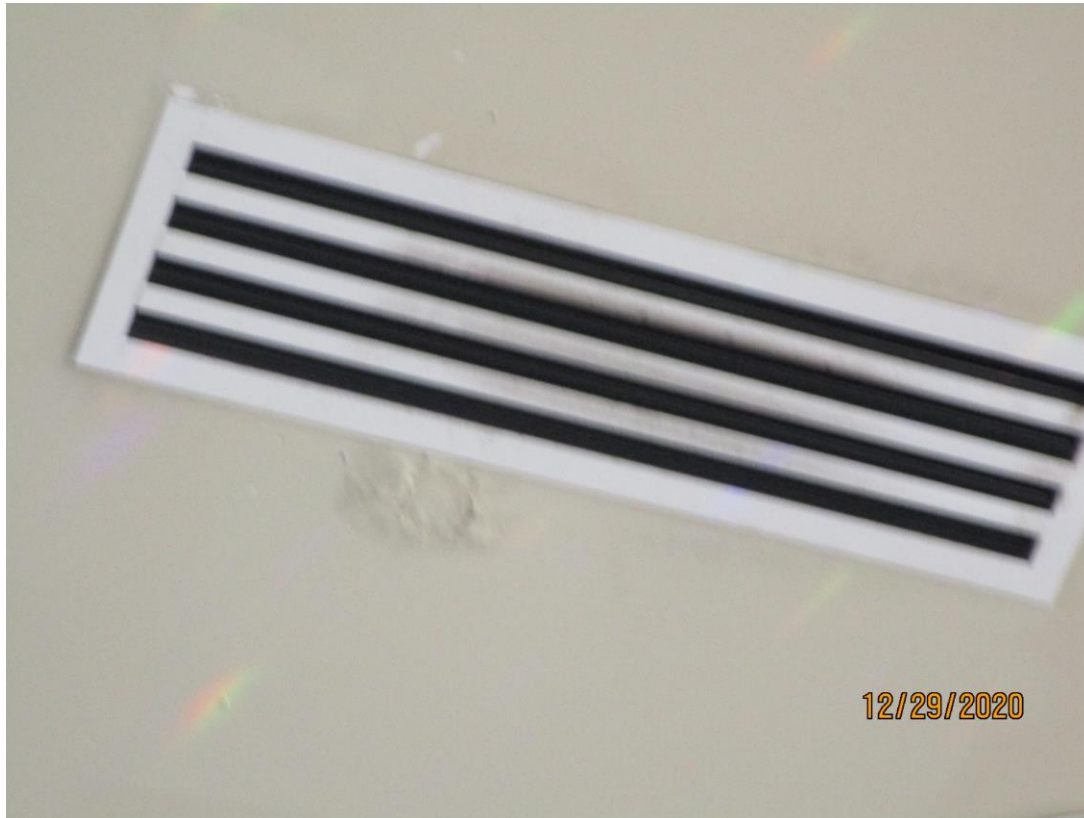
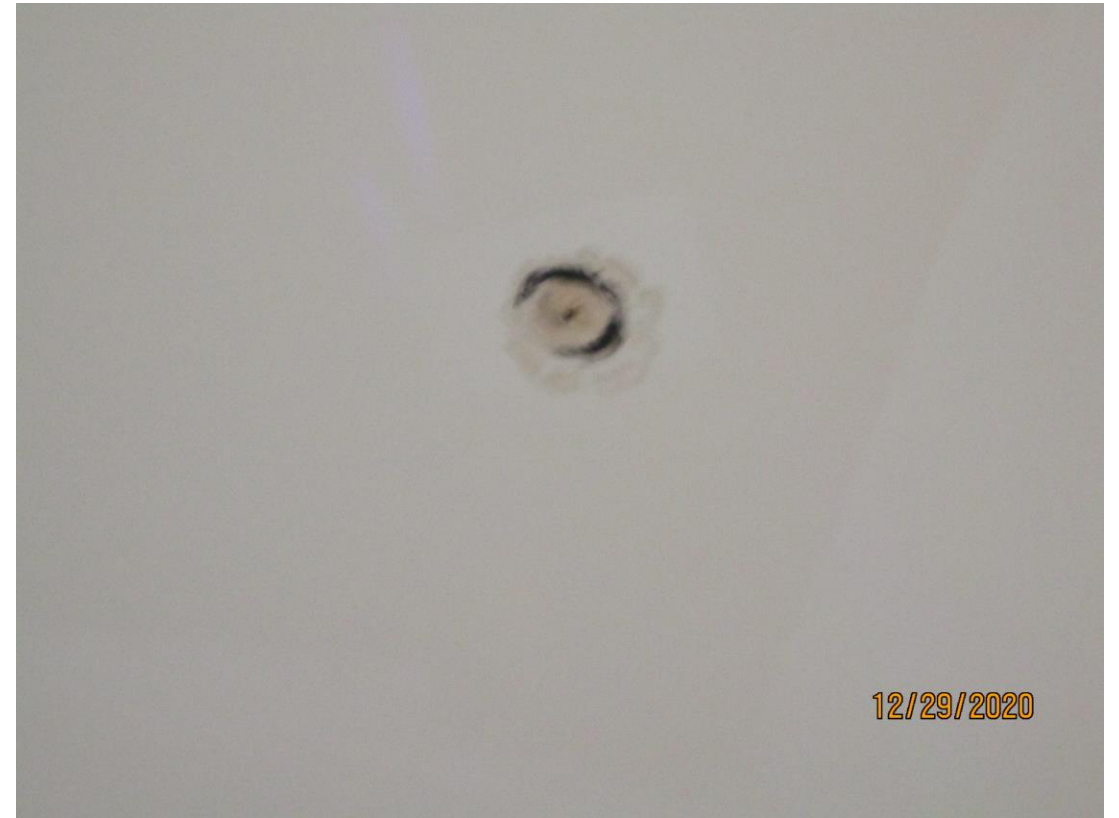
# Water damage in **East** and **West** walls baseboard in **Majestic Ballroom**

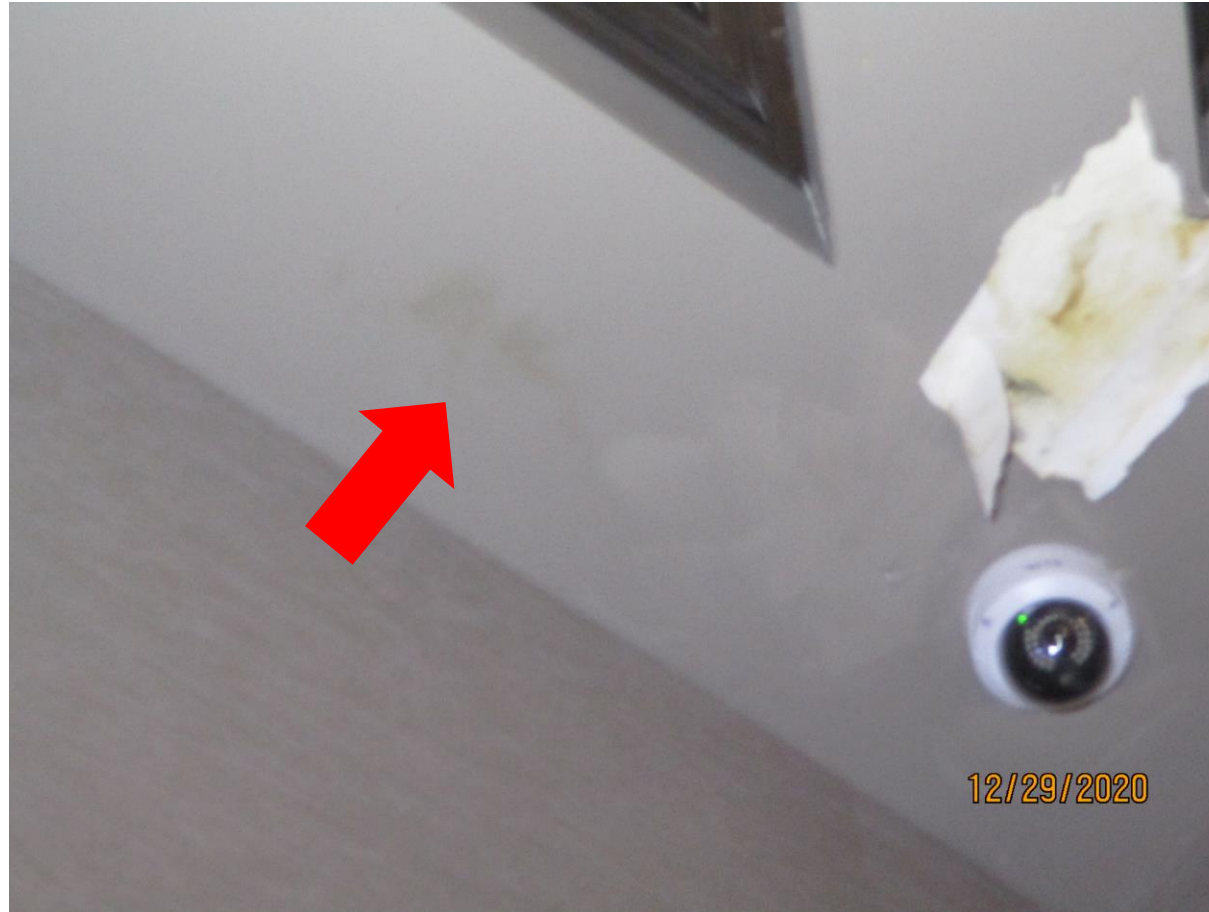
- The relative temperature of the **South Ladies Room** was **64.8 F°** and the relative humidity was identified up to **66.4%**.
- Apparently, there was a previous leak from the sprinkler system.
- There are visible water stains on the ceiling and suspect mold growth.
- The chiller lines run above the ceiling and appear to be sweating excessively.

# Water stains and mold growth on the **South Ladies Room ceiling**

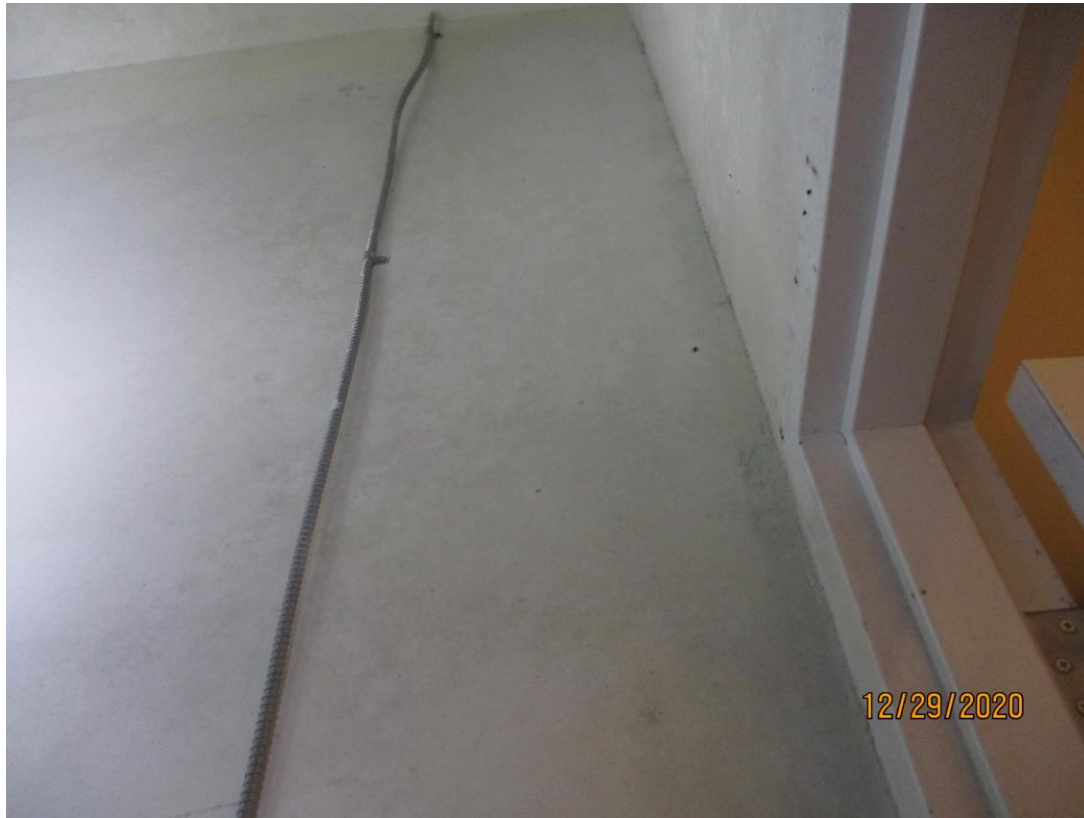
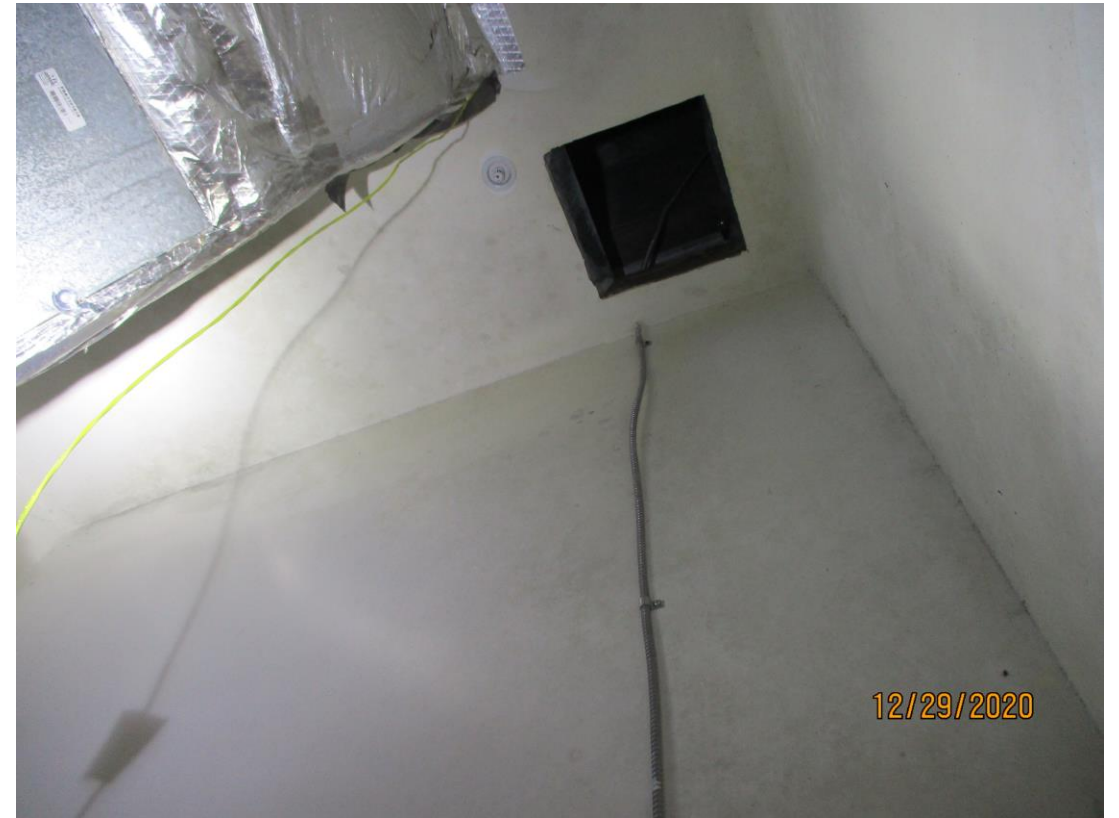
- There is heavy condensation from the chiller lines, which is creating elevated humidity inside of the mechanical room. Therefore, it is providing a fertile environment for mold growth on the walls, ceilings and on the air handler unit.
- There are also visible water stains and mold growth around the chiller lines and the entire room including the door.
- **One (1)** sample collect from the **Mechanical Room West Wall** identified high levels of toxic mold species too numerous to count (“**TNTC**”) and scientific finding are attached herein.
- A tape sample collected from the **Mechanical Room Ceiling** identified **Stachybotrys** too numerous to count (“**TNTC**”).
- Notably, **Stachybotrys species** is a black mold and considered toxic to

# Water stains and mold growth in **Mechanical Room North** wall and ceiling

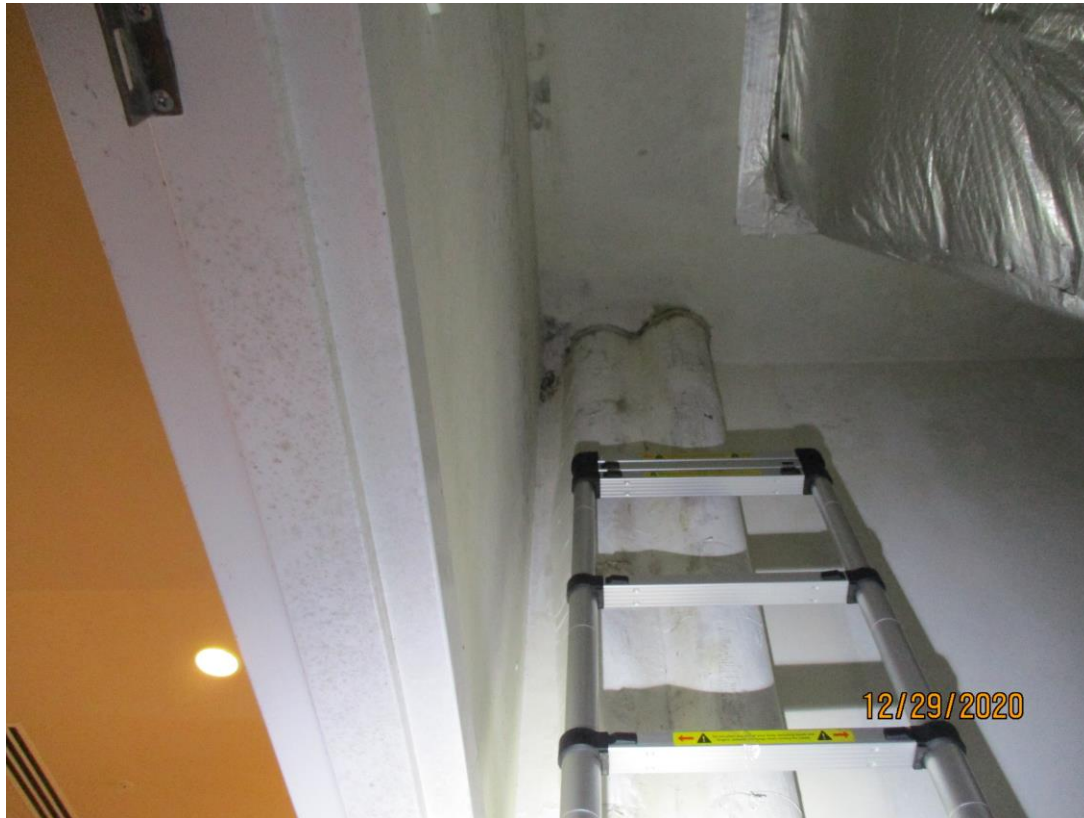
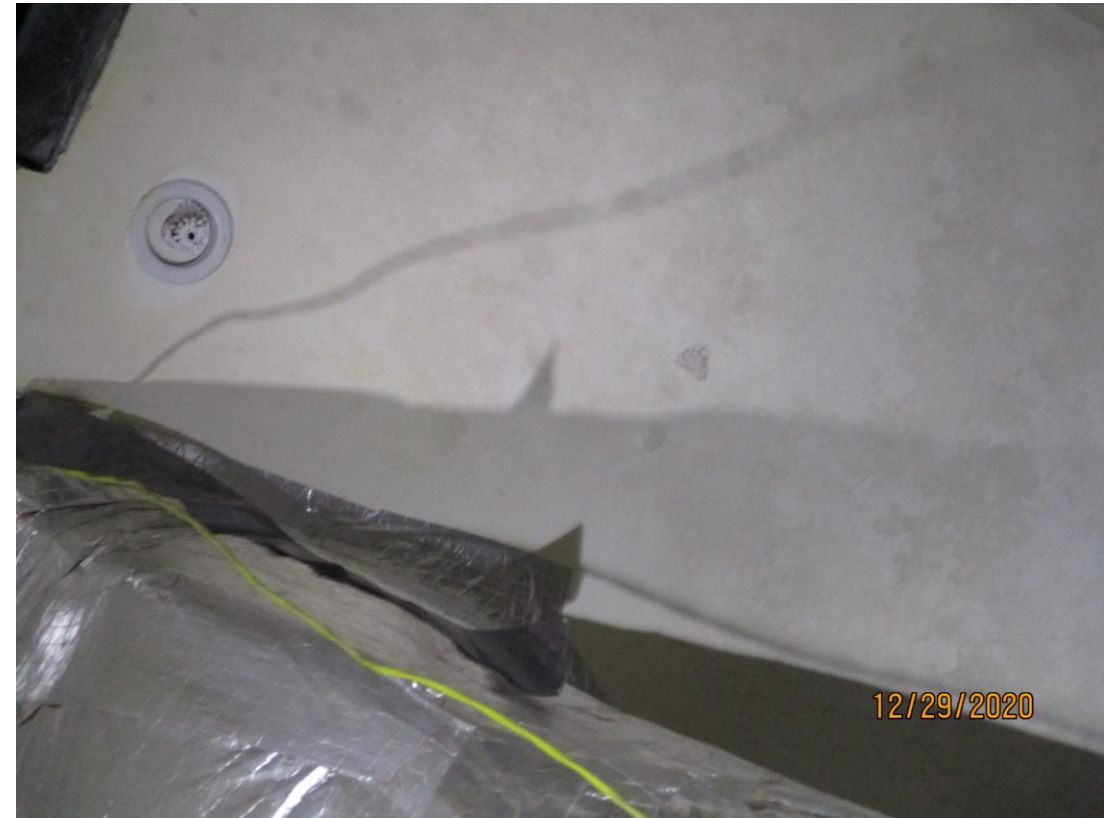
# Visible damage on A/C plenum

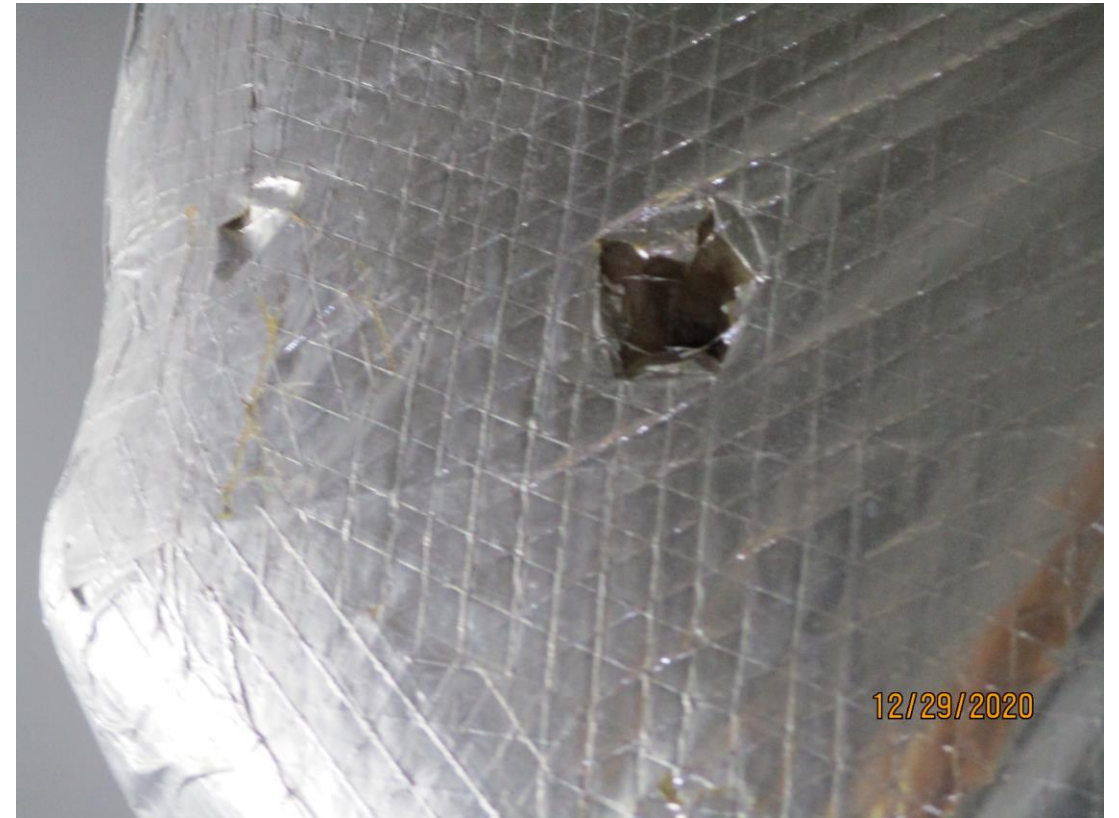
# Water damage and mold growth in **Mechanical Room North** wall behind the chiller lines
